# **Nine Elderly Fire Victims in Residential Hotel Miami, Florida (April 6, 1990)**

**Investigated by: Charles Jennings**

**This is Report 041 of the Major Fires Investigation Project conducted  
by TriData Corporation under contract EMW-90-C-3338 to the United  
States Fire Administration, Federal Emergency Management Agency.**

## **Nine Elderly Fire Victims in Residential Hotel Miami Beach, Florida**

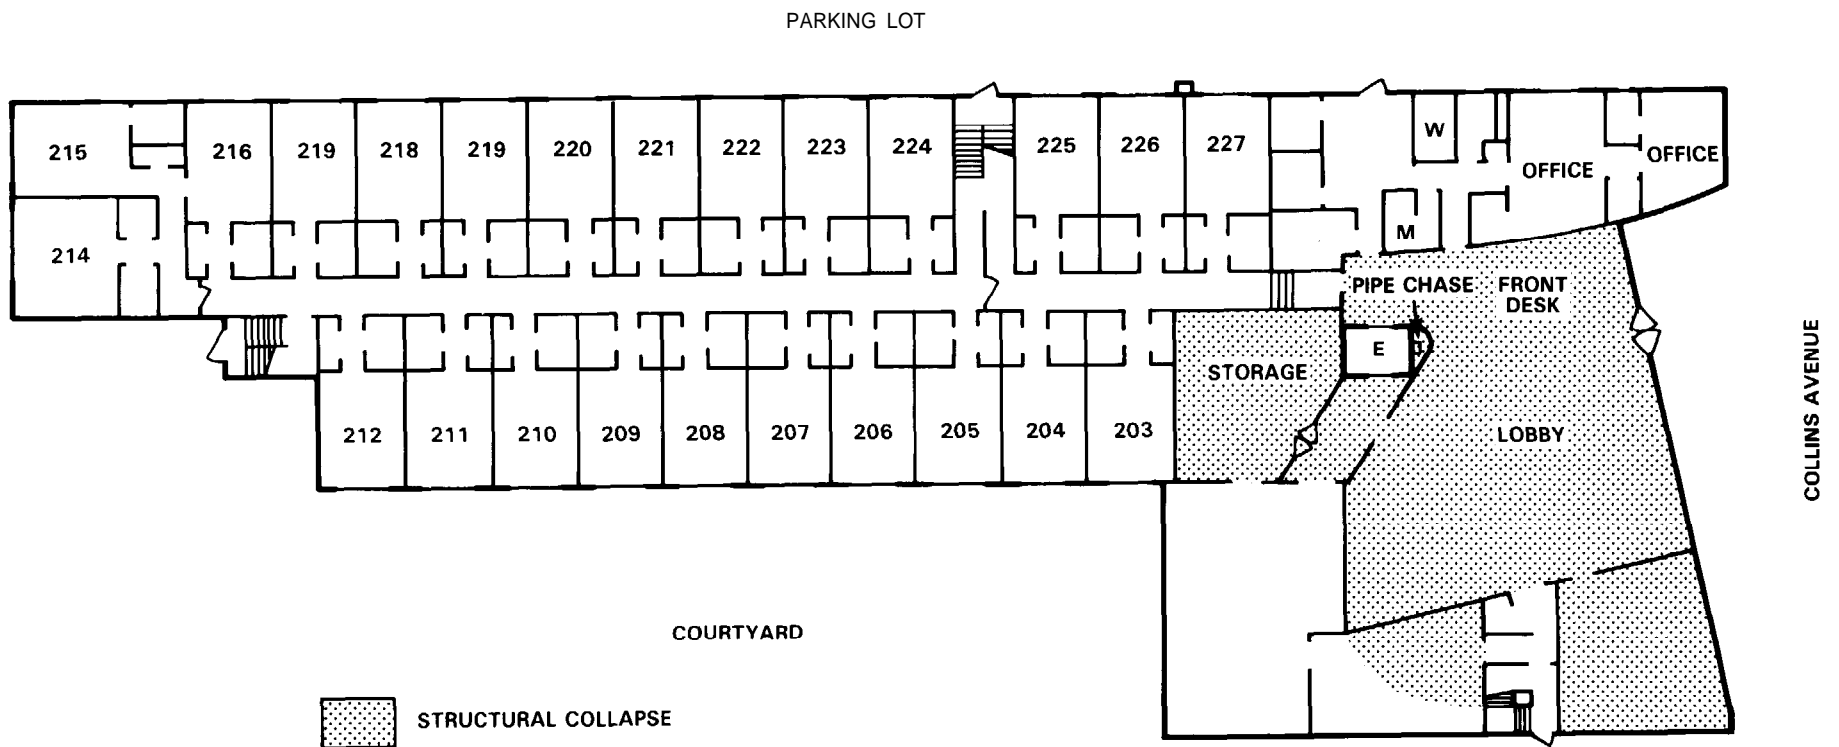
LOBBY FLOOR PLAN - FONTANA HOTEL, MIAMI BEACH, FLORIDA

Attack on the fire was finally changed to a defensive mode due to deteriorating conditions within the structure. The fire had made significant headway in concealed spaces and the attic before it was discovered. The second floor had collapsed into the lobby about an hour into the blaze. The fire extended into the attic and burned the length of the building over the next several hours. Fire dropped from the attic into the third floor as it consumed the roof. The fire burned about four and one-half hours before being brought under control. Ultimately, much of the roof was destroyed as fire spread through the attic space. The front section of the building was basically gutted, with the fire burning through the room and causing collapse of the upper floors into the lobby area. (See Appendix A.)

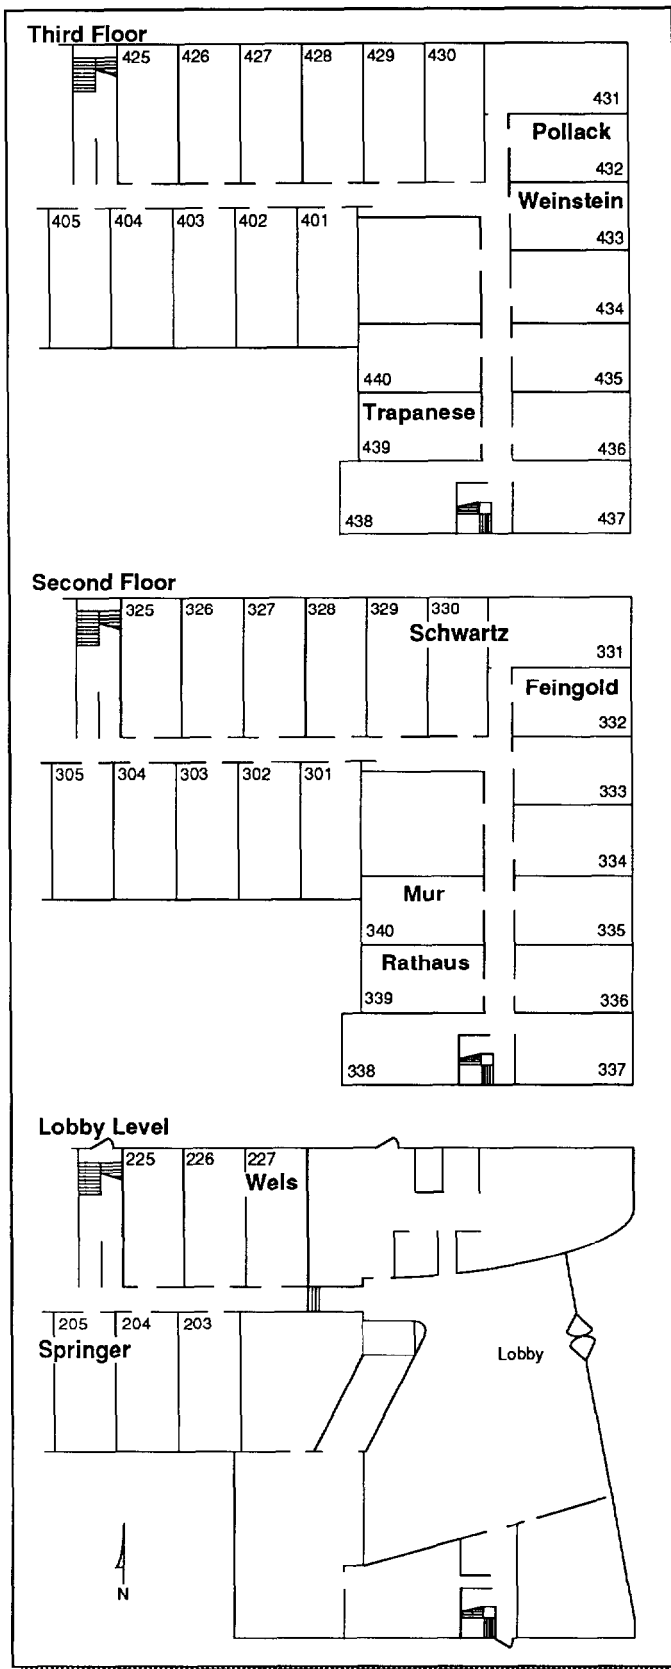
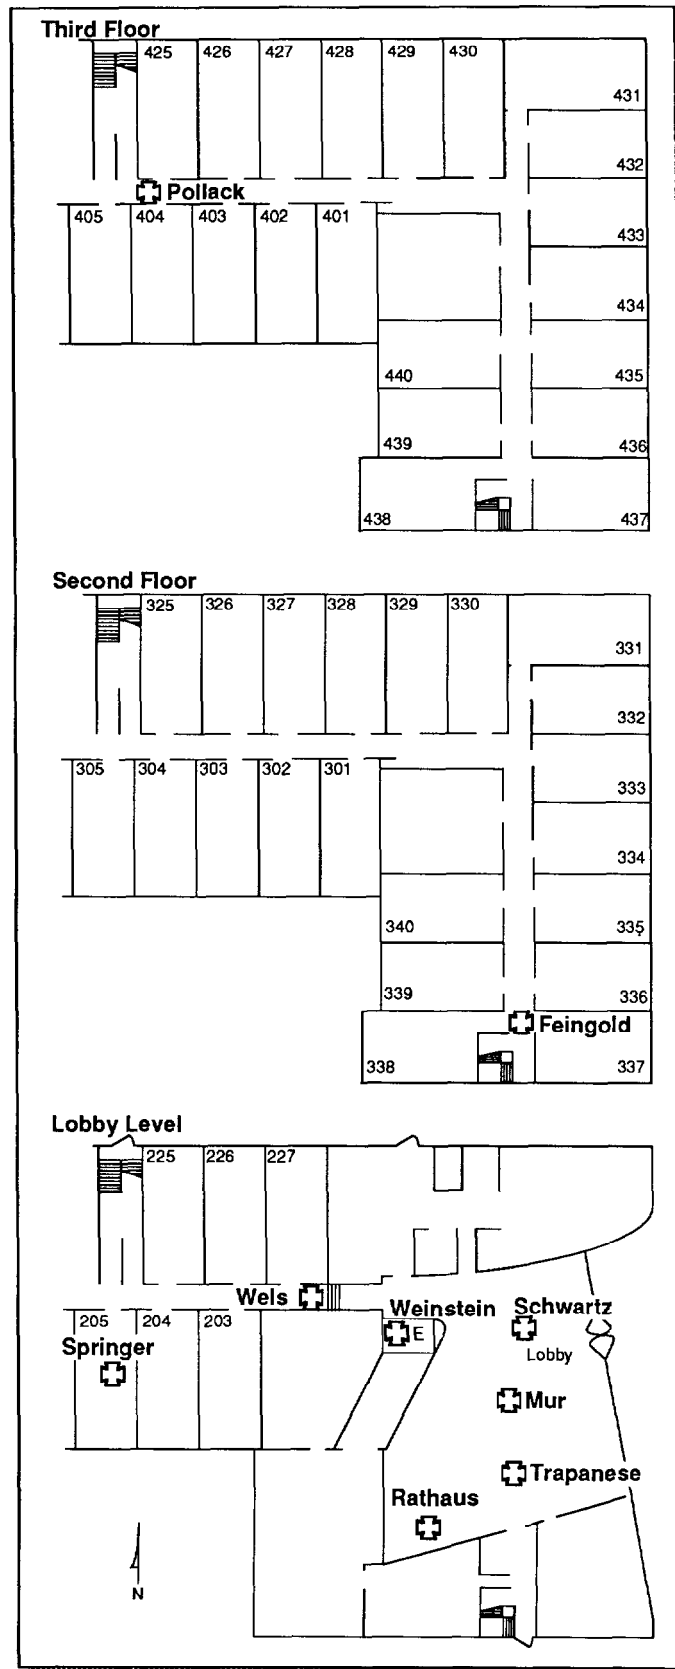
**Enlarged Floor Plans Showing Room of  
Residence and Final Position of Victims**

The Miami Beach Fire Department estimates that there were about 140 people in the Fontana Hotel on the morning of the fire. Most occupants were asleep when the fire was discovered. Of the nine fatalities, several were overcome while attempting to exit the structure. A complete listing of victims with ages and room of residence is included in Appendix B. A floor plan showing the room of residence and position of fatalities when recovered is included as Appendix C.

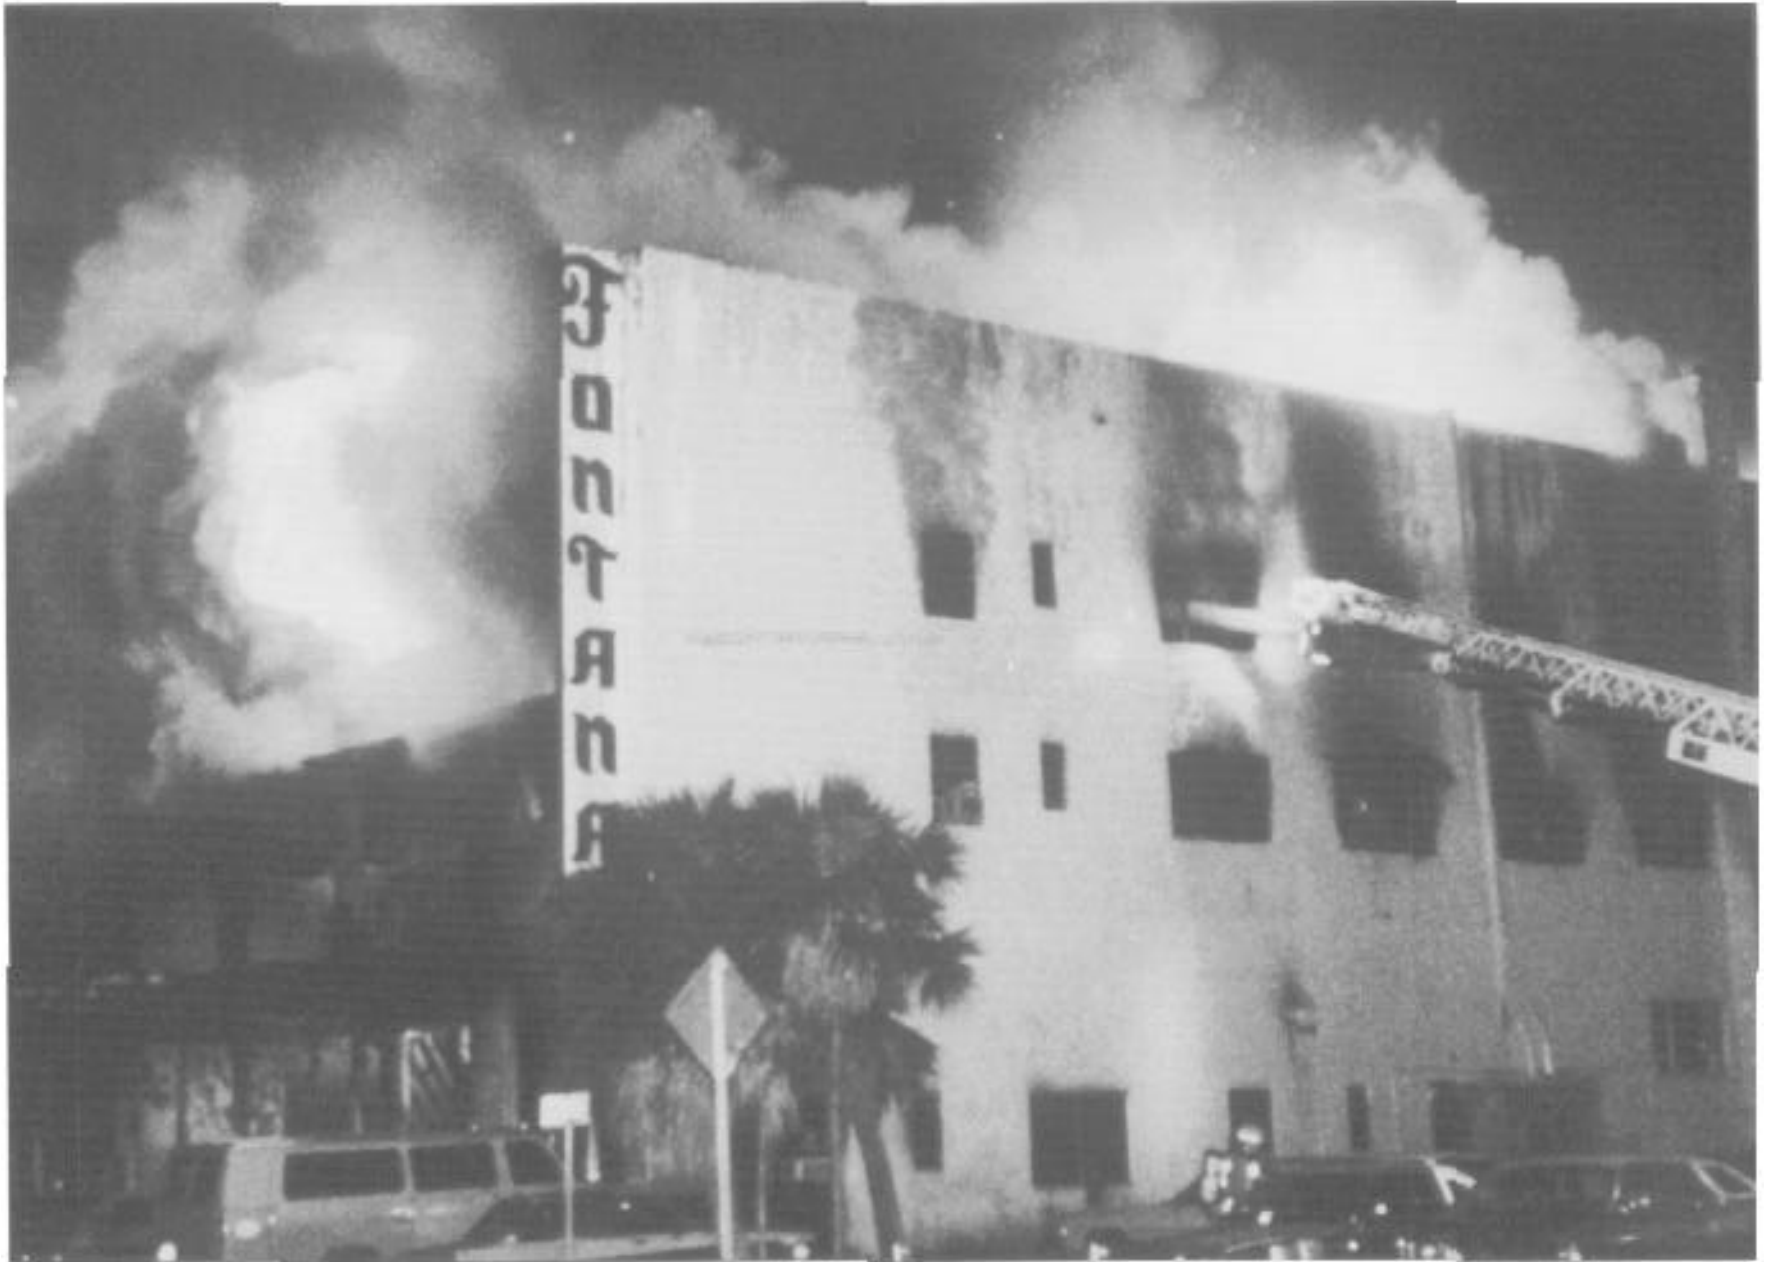
Exterior attack in progress, note fire involvement of attic.

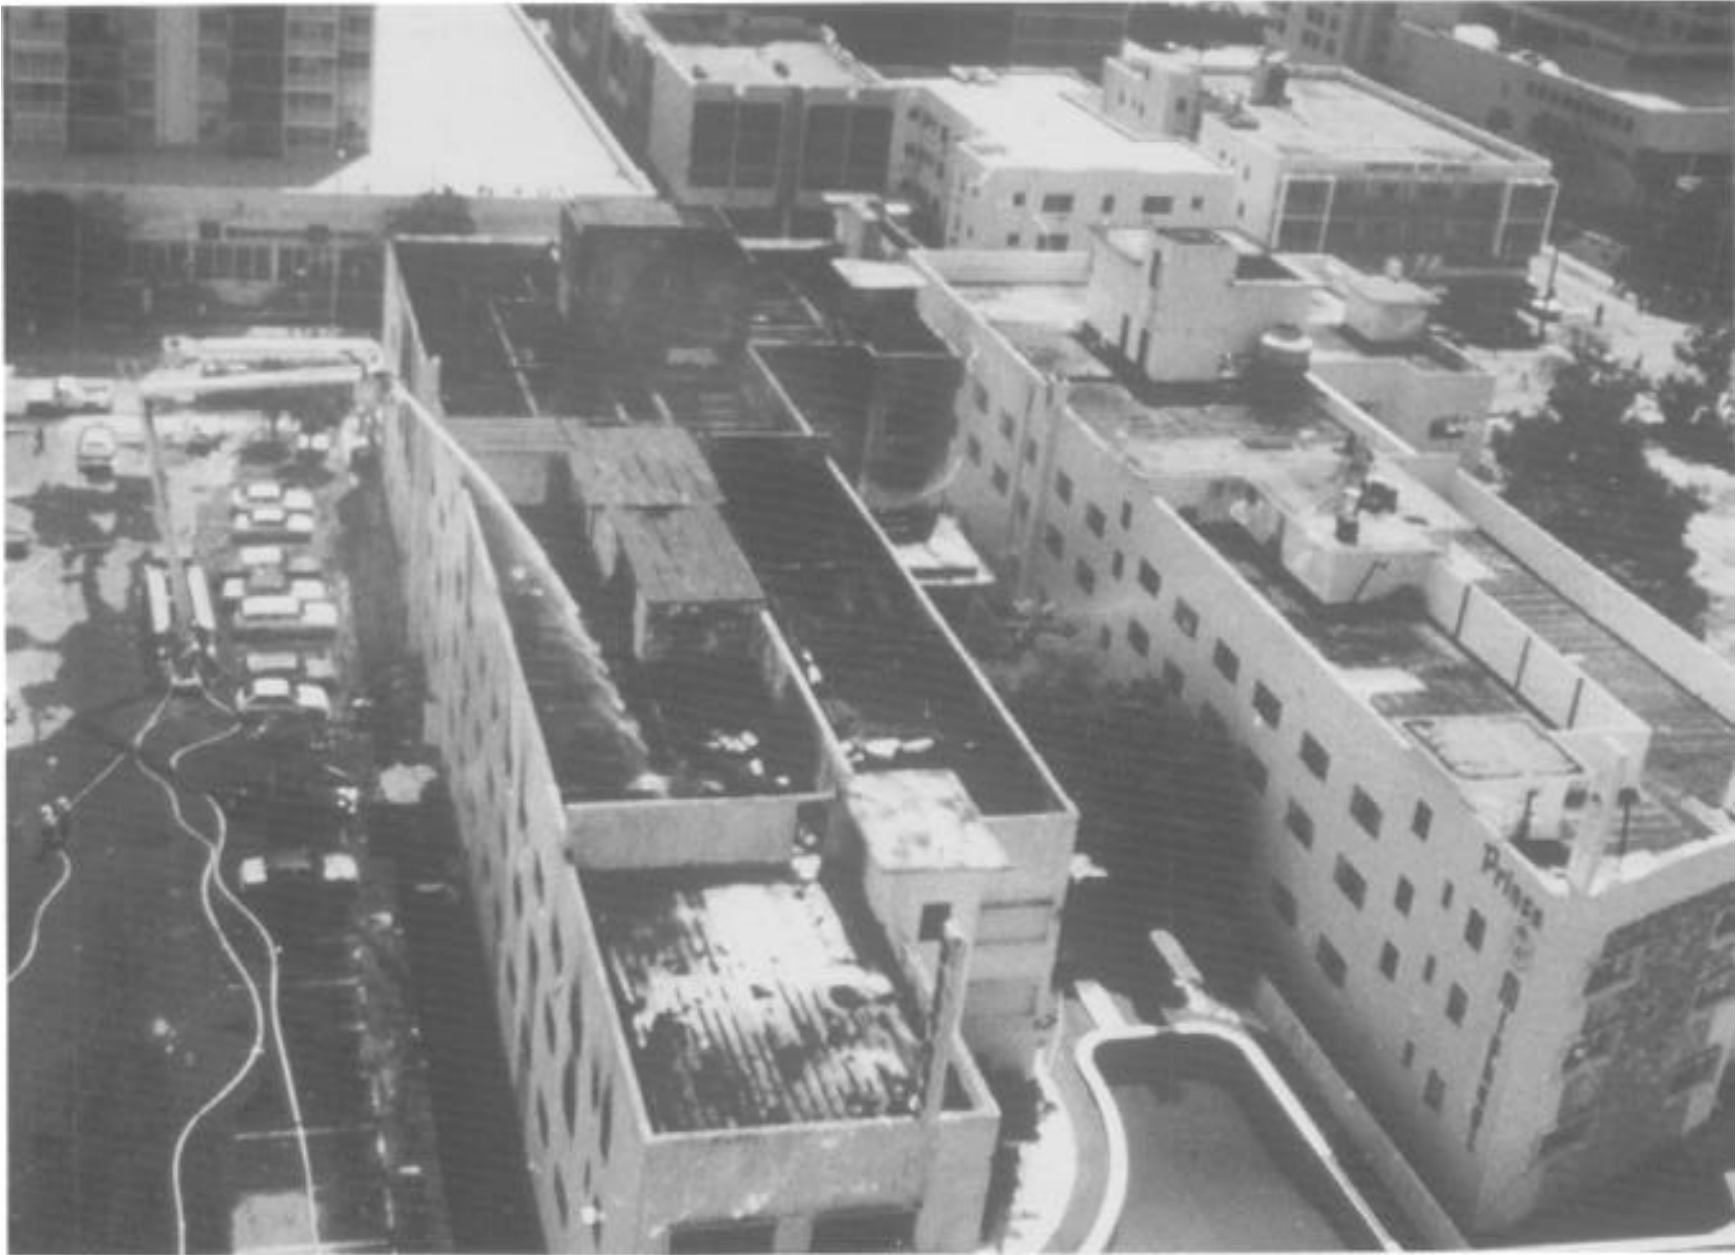
Aerial view of Hotel after the fire. Note destruction of the roof and proximity of the Prince Michael Hotel. *(MBFD photo)*

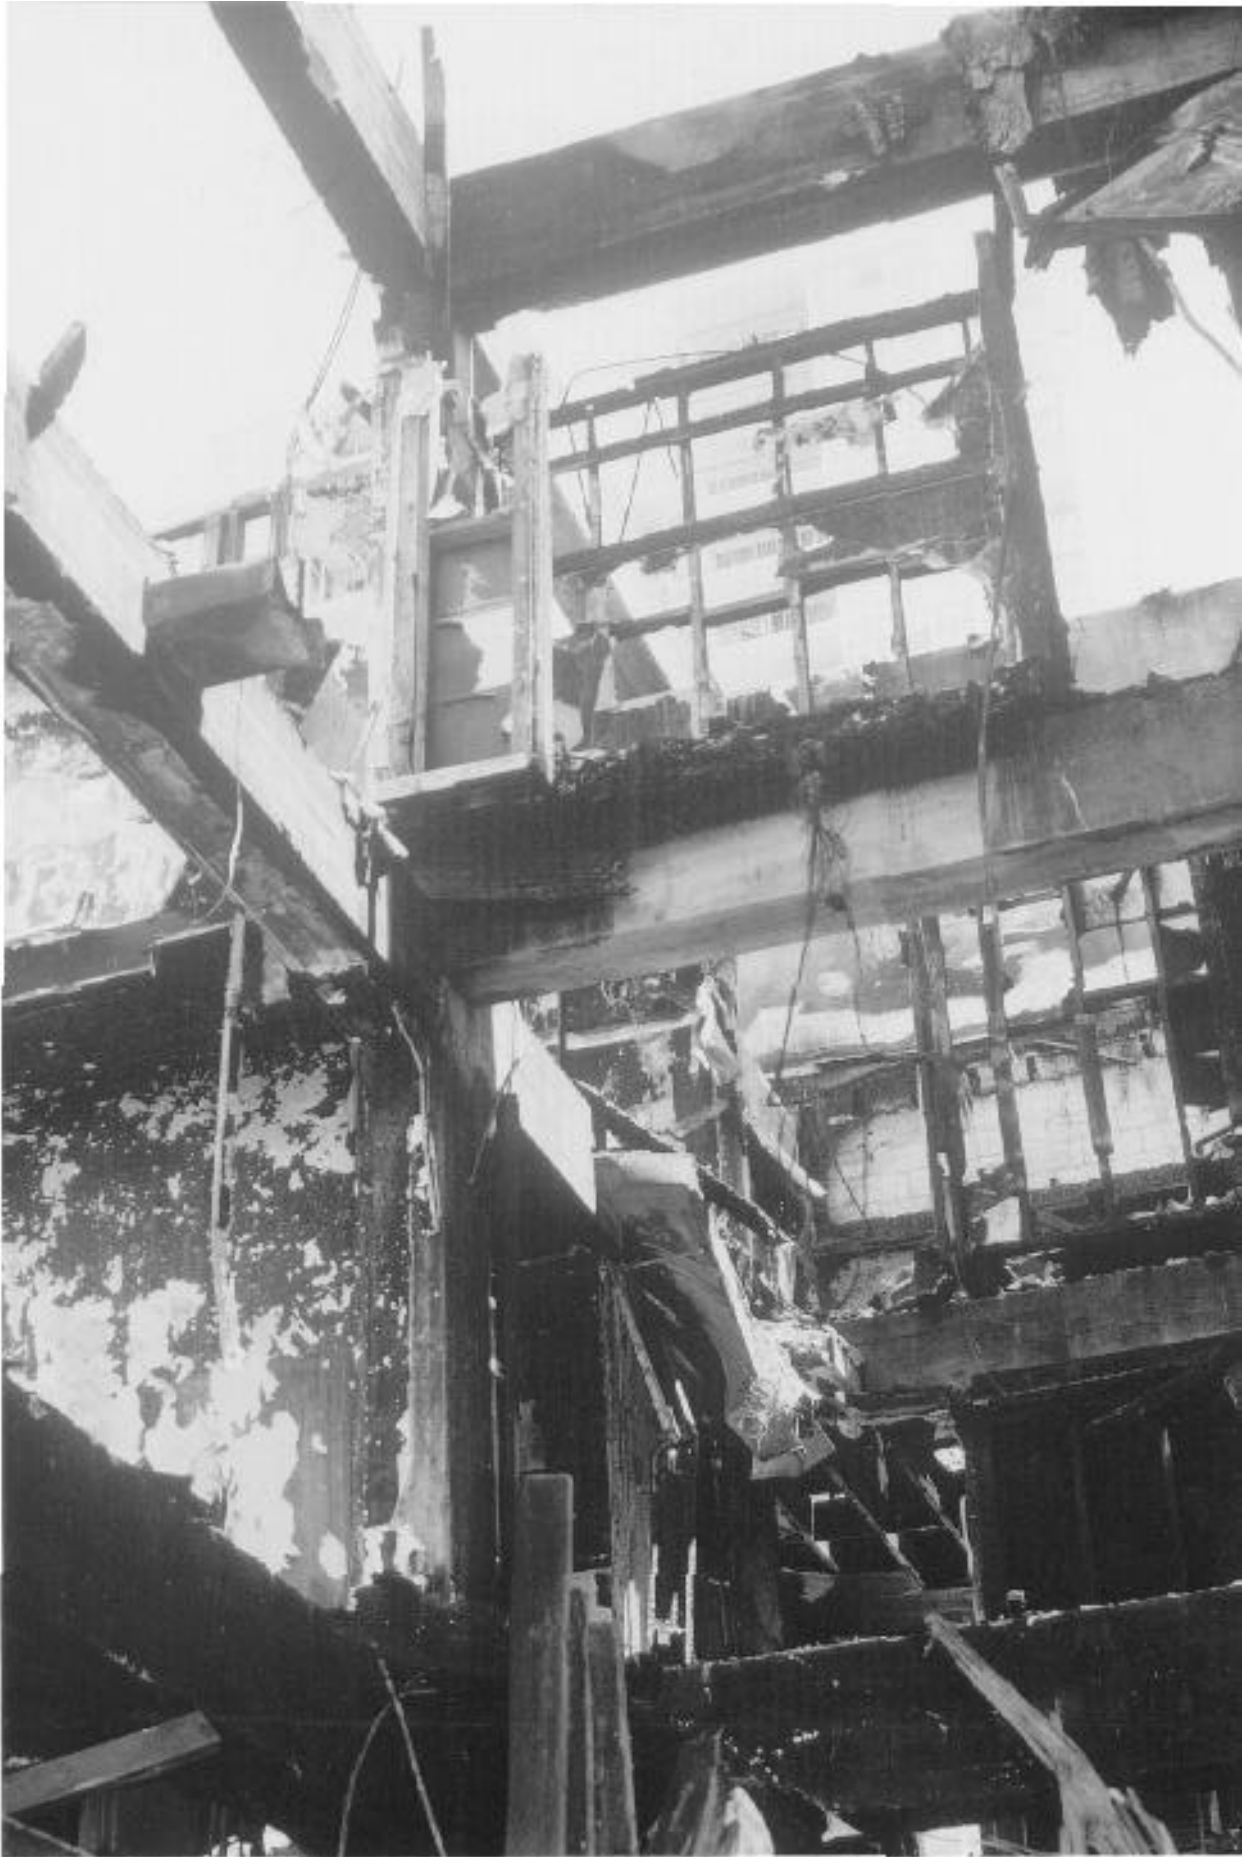
Lobby, looking up through roof facing Collins Street.

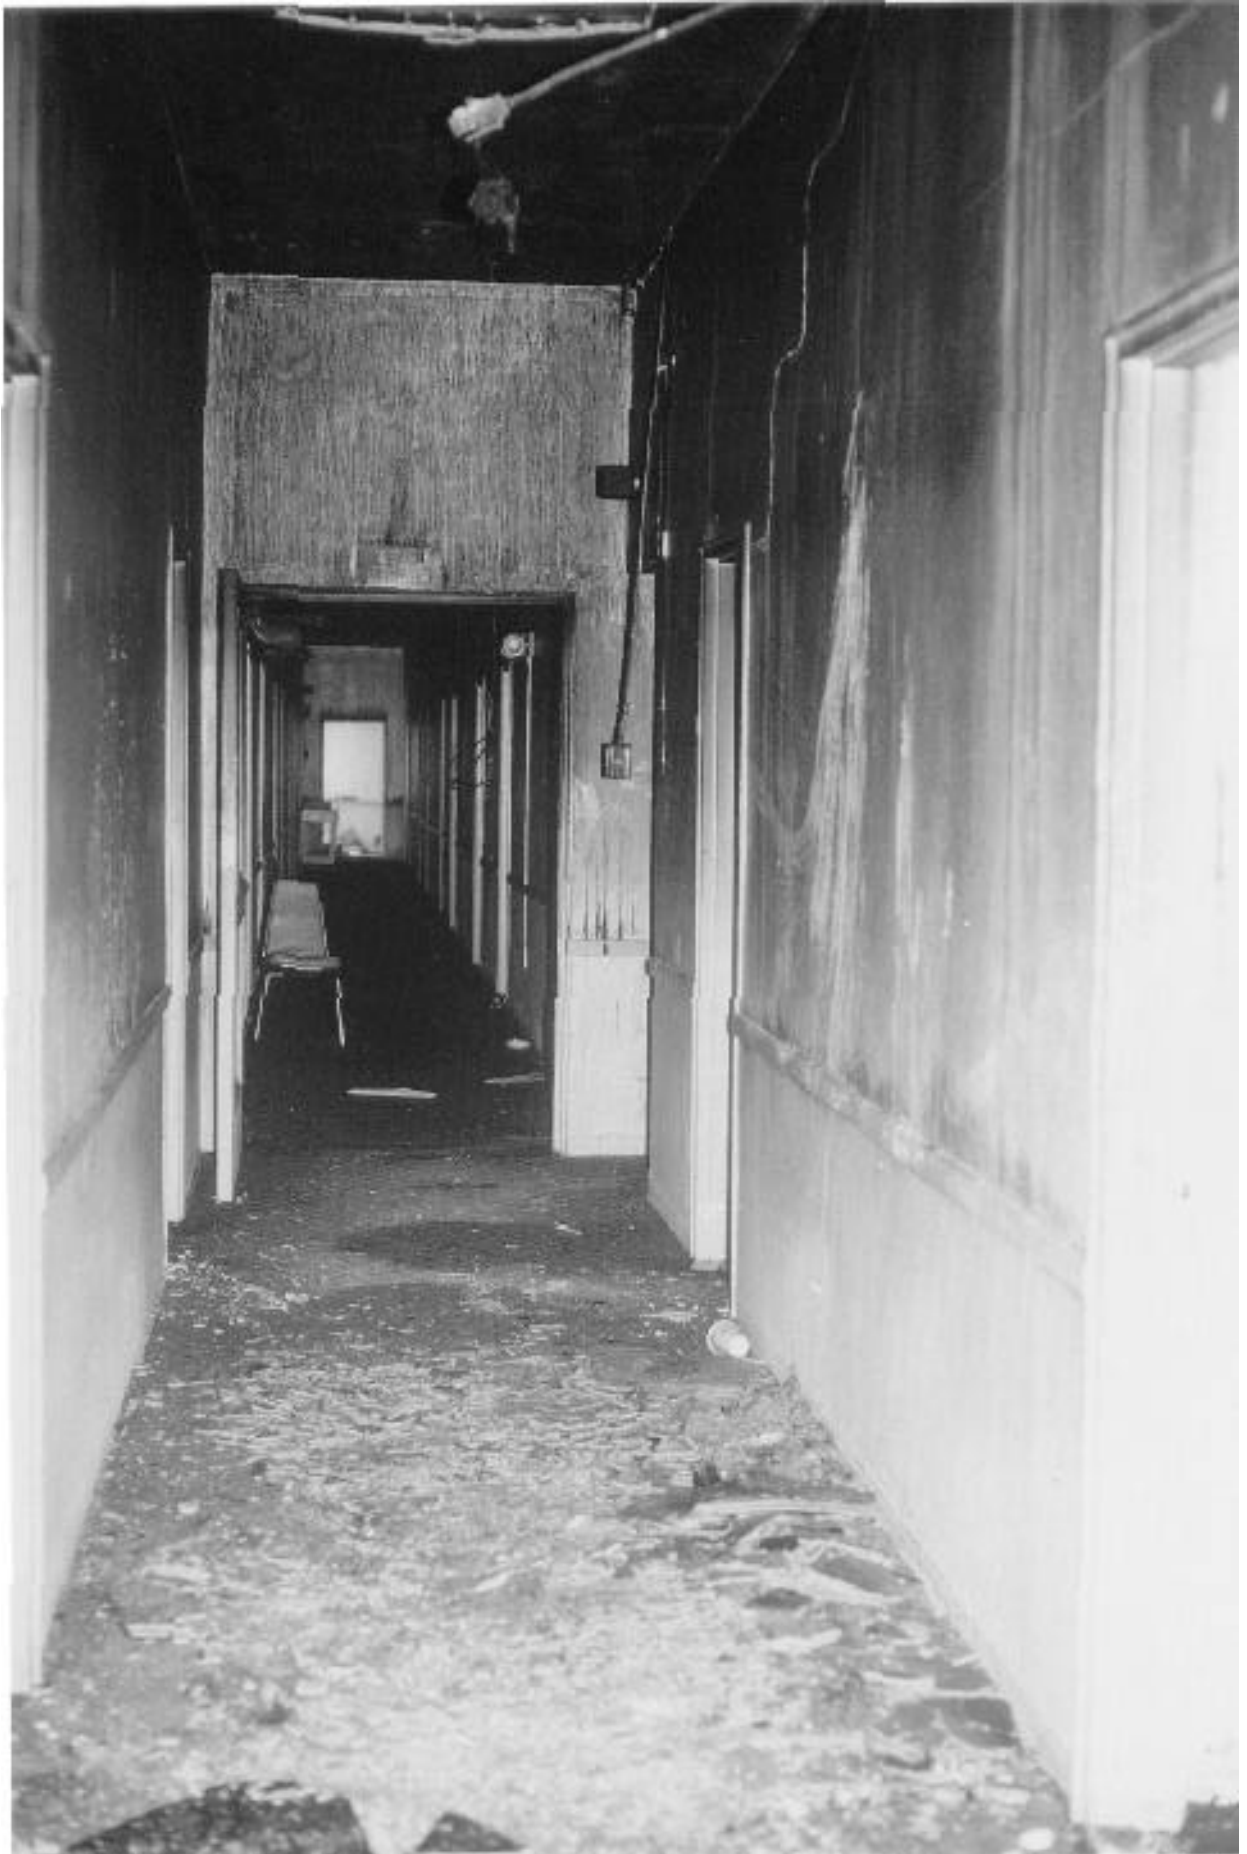
First floor corridor, looking to rear of building from lobby. Fire door in foreground was closed throughout much of the fire.

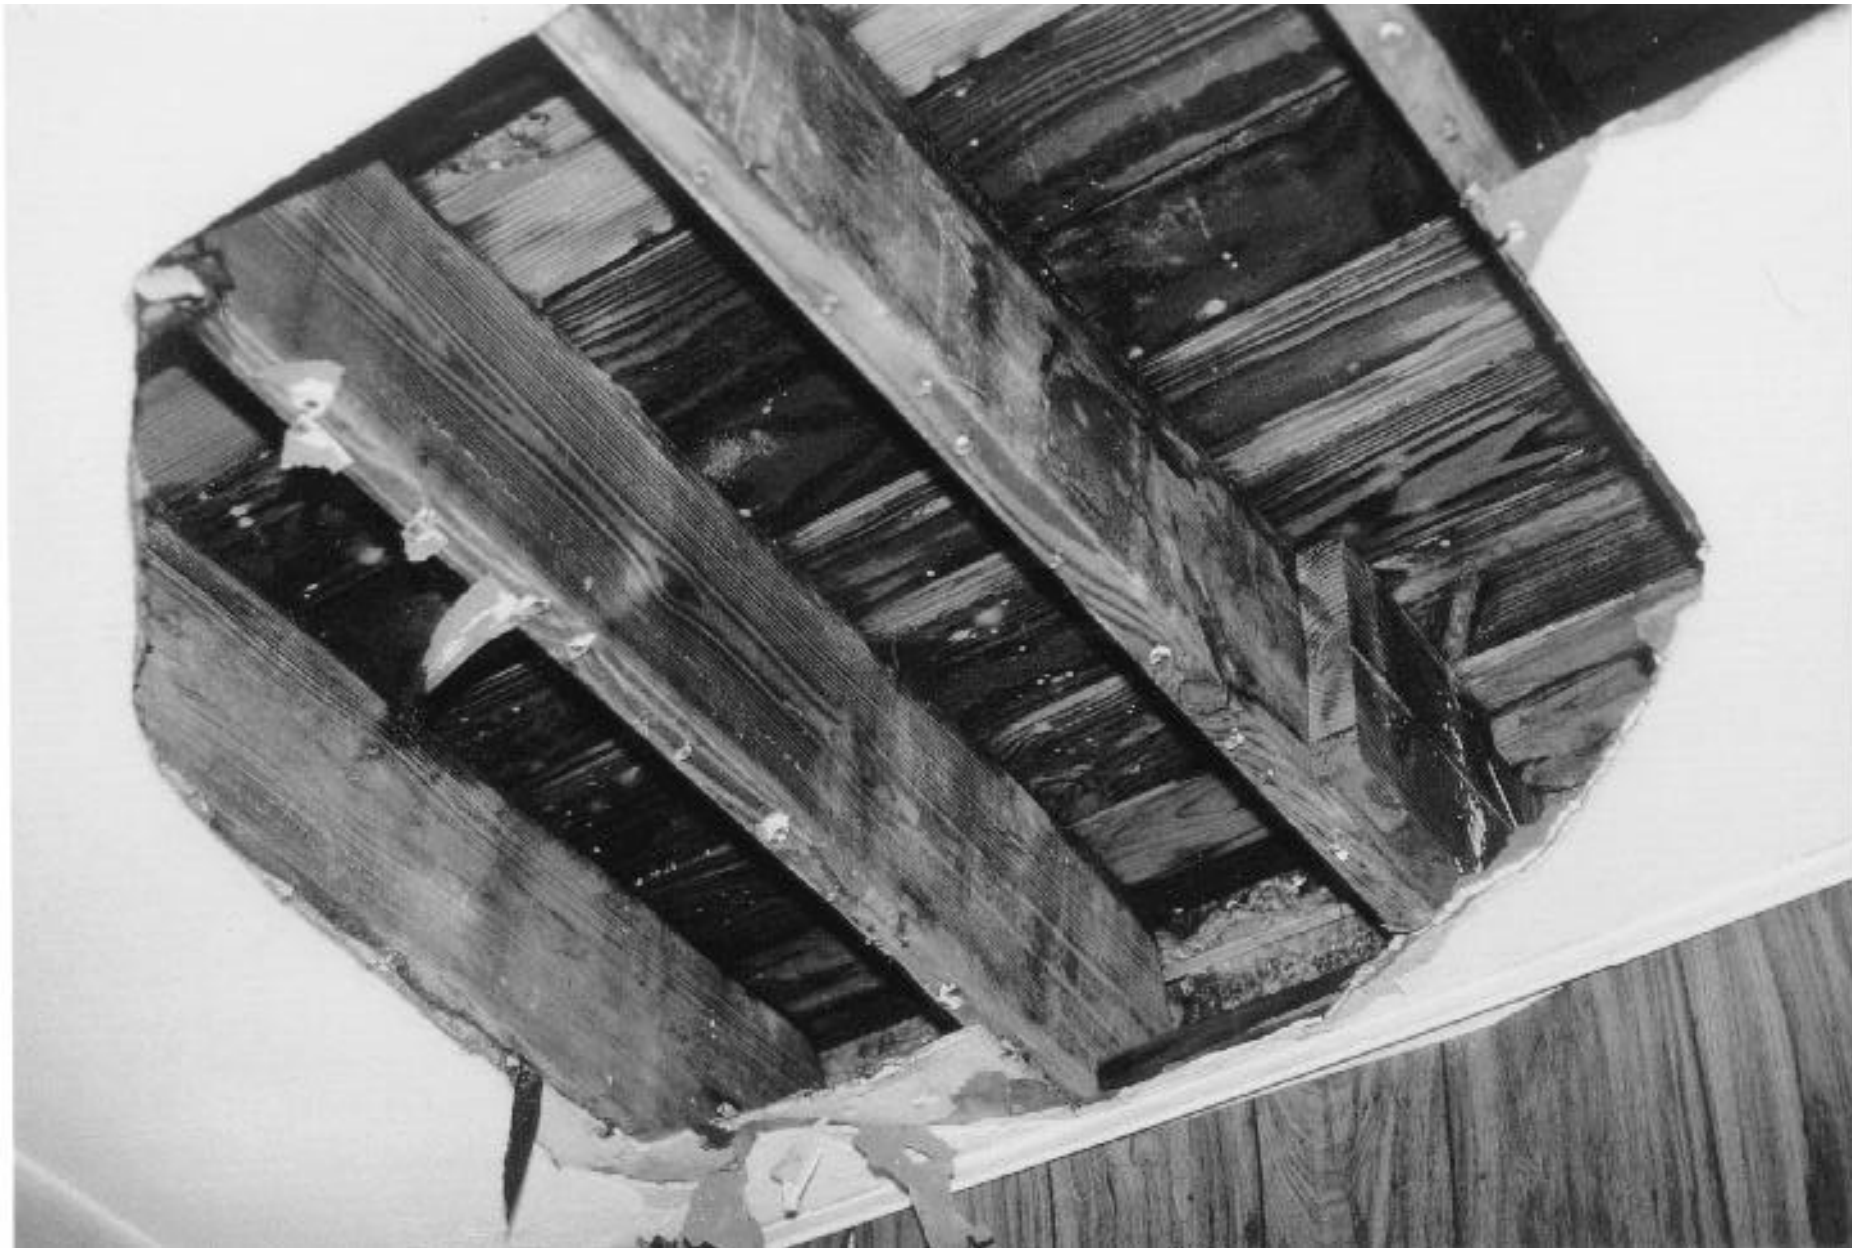
The construction of the building created concealed spaces which ran the length of each floor in the space between the floor and ceiling. In addition, there was a major pipe chase which ran from the first floor ceiling to the attic. This pipe chase, which was adjacent to the elevator shaft, was approximately live by ten feet and carried plumbing and other building services (see floor plan, Appendix A). The interior framing of this pipe shaft was exposed wood. The openings on to each floor were not fit-estopped.

This pipe chase and the construction of the floors effectively created a single concealed space that ran the length of the building from the first floor to the attic. A photograph of typical floor construction is included in Appendix E.

Typical floor construction, shown from ceiling of first floor room.

Providing combustible concealed spaces with detection or suppression systems can prevent these types of fires from spreading before being detected.

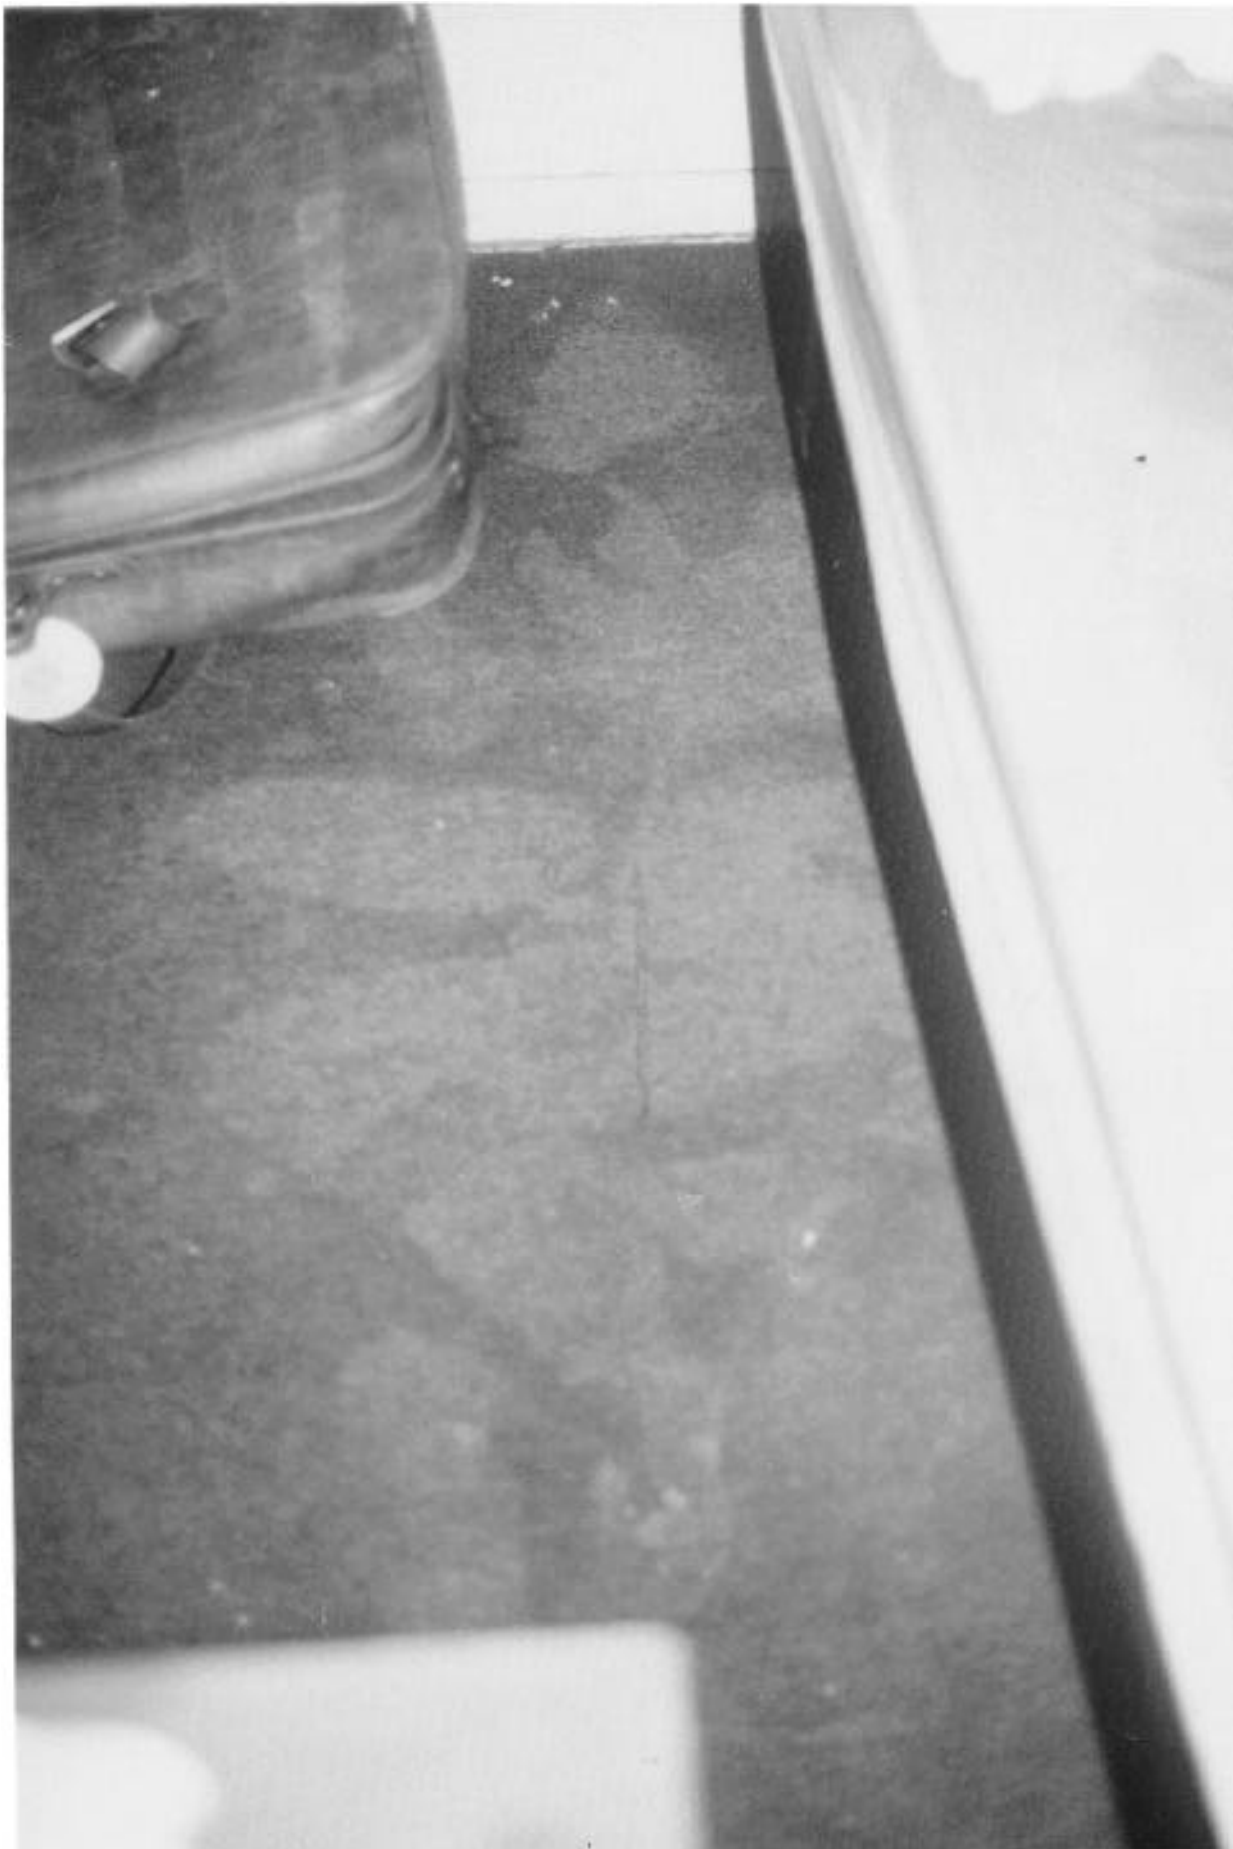
One fatality, whose room was located across the hall from an exit, was discovered fully dressed, with coat and shoes, and had a purse containing valuables. Apparently, she took time to get dressed and collect valuables before leaving. She was found on the floor of her room carrying a flashlight, which was still on when she was removed. Her delay to gather belongings cost her her life. A photograph of her room (205) showing its closeness to the exit is included in Appendix E.

Outline of victim in smoke stain, Room 205. Victim was reportedly found carrying a flashlight (still on) and personal belongings in a purse.

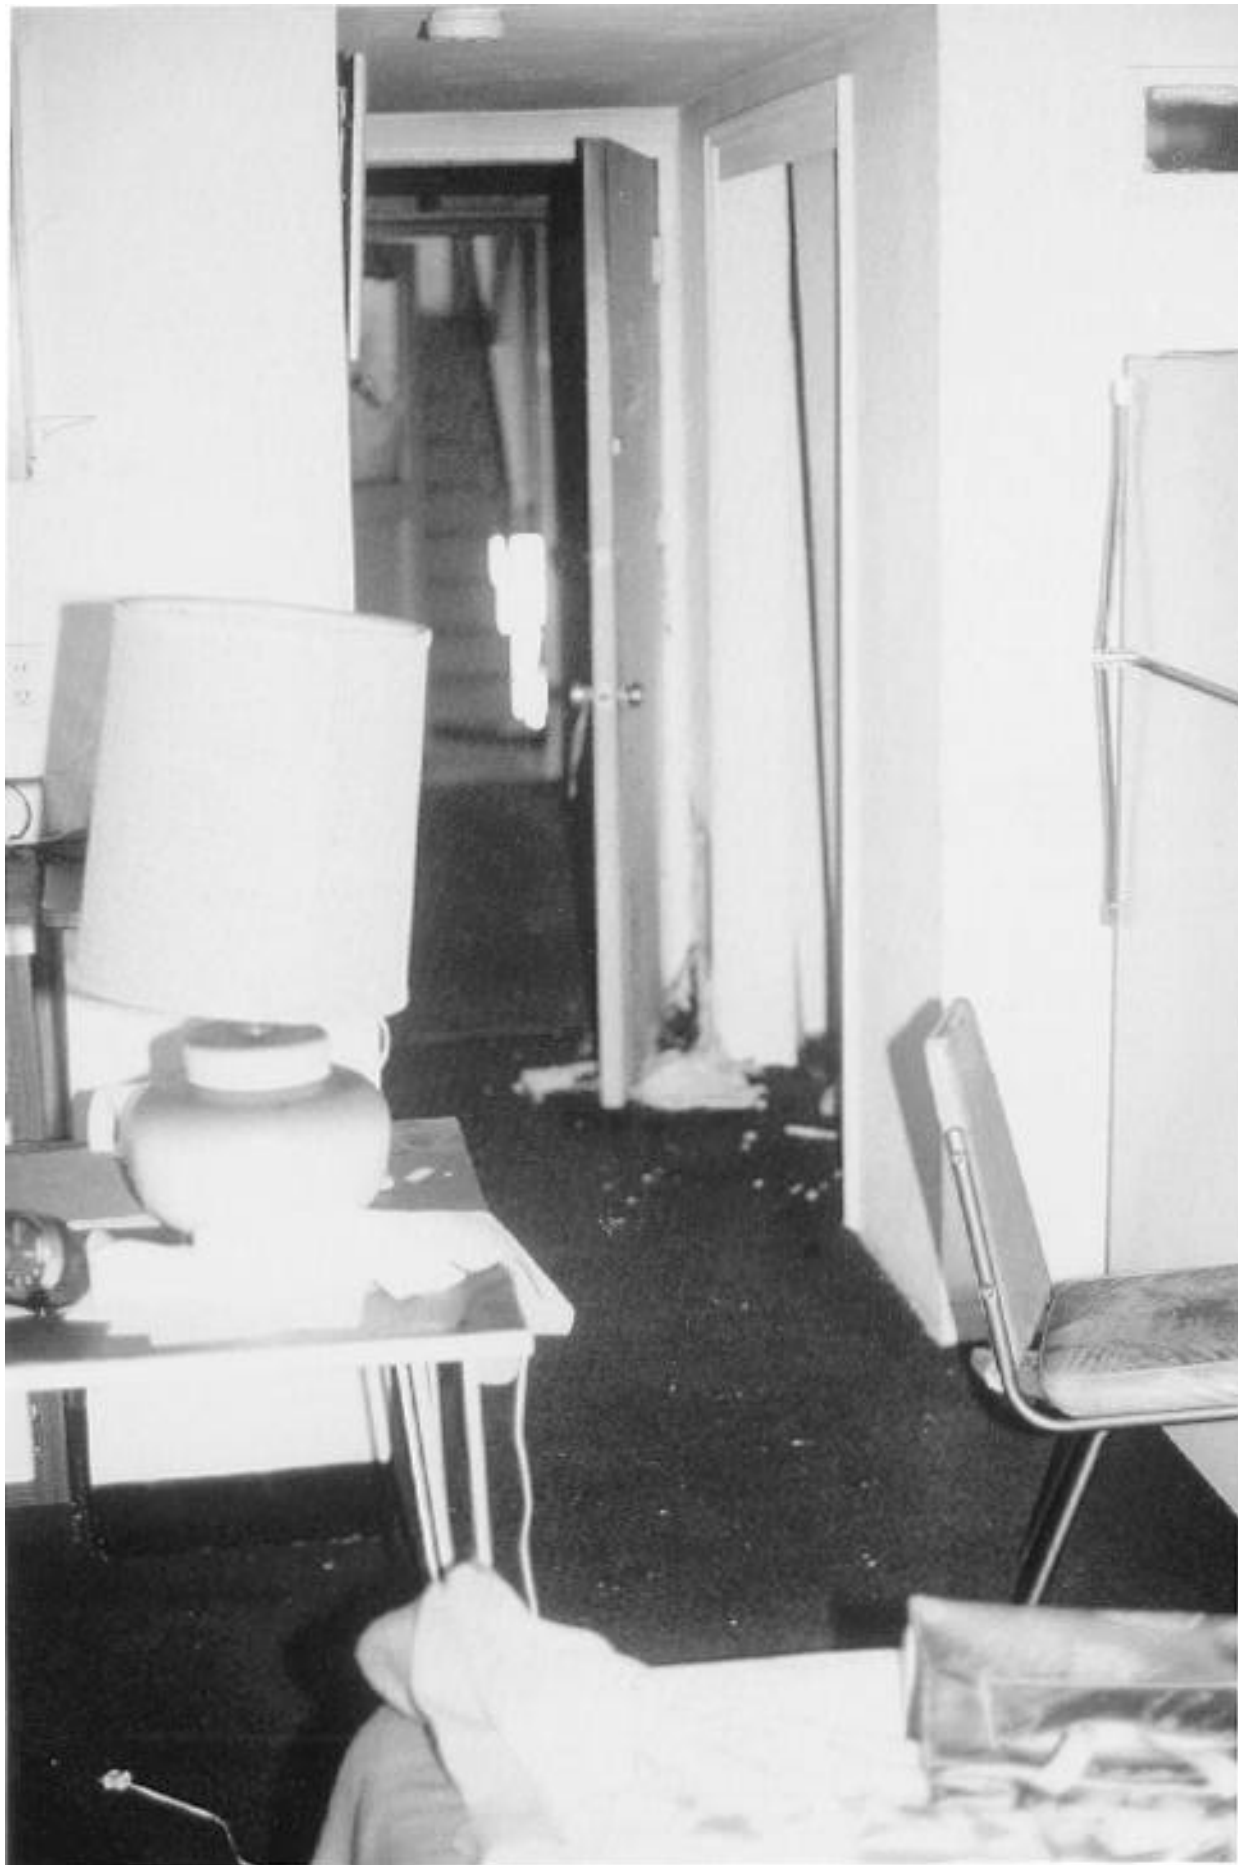
View of Room 205, fire exit is visible across corridor.

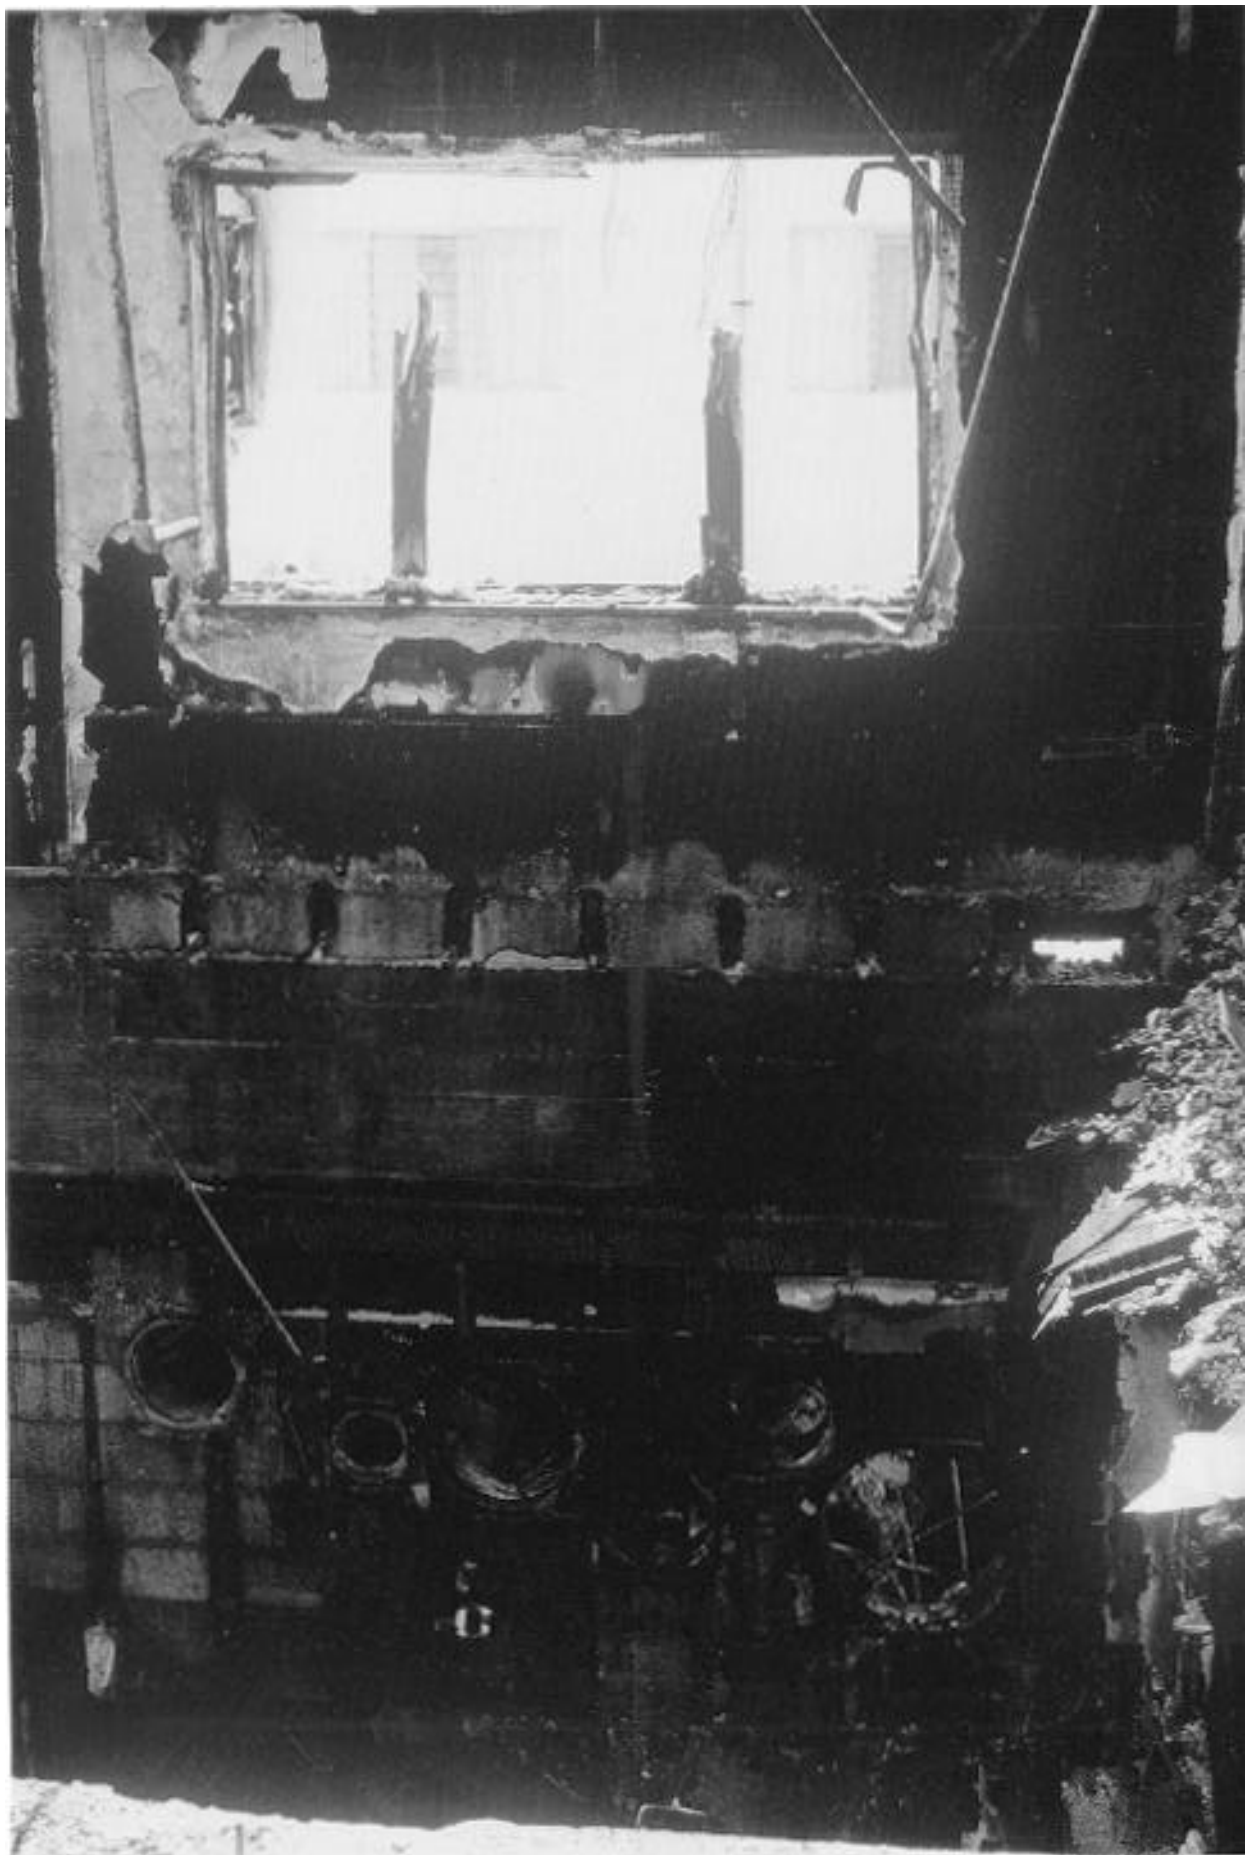
Second floor, looking across to Room 301 from front stairway, area of origin is at base of photo.
